First insights into the Chamoli disaster, February 7 2021

UPDATED VERSION FEB 20, 2021 (Updates see page 9)

Purpose and scope

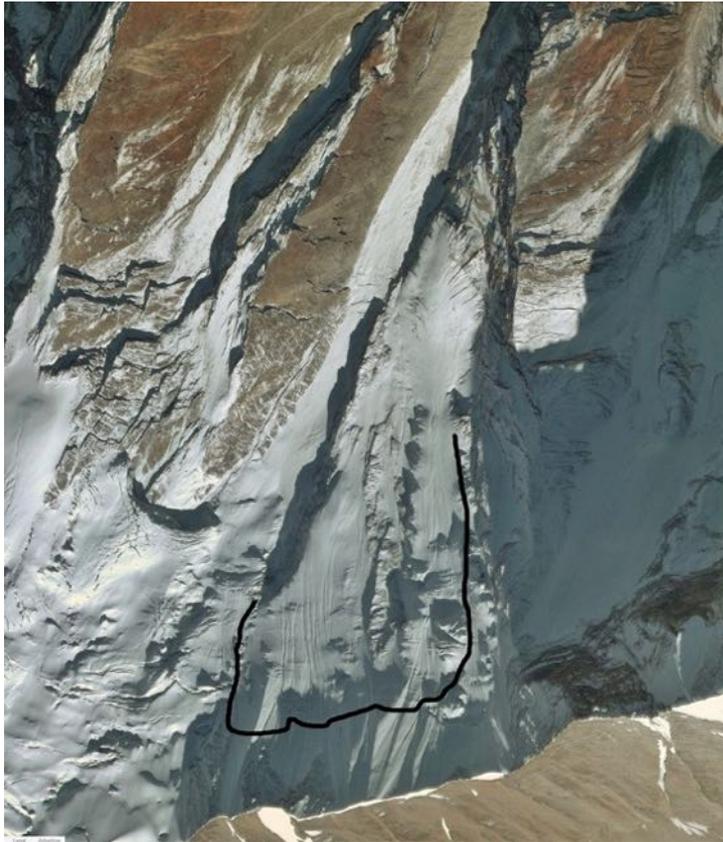
A high resolution satellite image of unknown date, but acquired before 2016, clearly shows a slope-parallel, downward layered rock structure underneath the detached ice masses (Figure 7). Such a structure favors the detachment of slope-parallel rock slabs, in particular when water enters the contact layers of the slabs or when ice at this contact layers is melting.

Figure 5: High resolution image of unknown date (prior to 2016), showing a slope-parallel, downward layered rock structure. Detachment zone of the 2021 avalanche indicated by black line. (Source: www.bing.com/maps, courtesy of Silvan Leinss).

Based on this information, we currently think a failure within the bedrock is the most likely trigger of this avalanche. *In the meantime confirmed, see update Feb 20, below.*

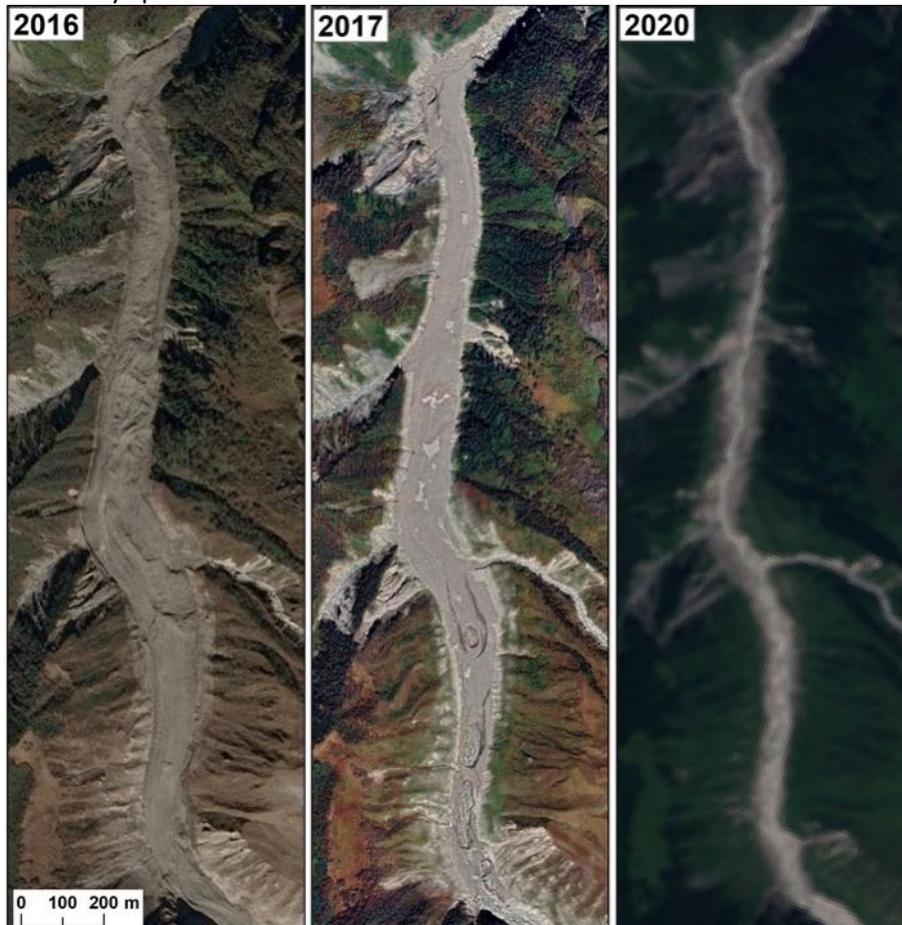
In turn it was found that the deposits from the 2016 ice avalanche of the neighboring glacier in the valley below the Feb 2021 avalanche have had disappeared more or less before the recent event (Fig. U1-5). Thus, buried ice deposits have not played a major role as a source of water for the flood, as initially speculated.

Figure U1-5: Deposits of the 2016 ice avalanche from the neighboring glacier. The 2020 pre event Sentinel-2 image (right panel) indicates normal flow of the river. The debris-covered ice, visible in the left and central panel from 2016 and 2017, seem to have disappeared before the 2021 avalanche. (Courtesy of Mikhail Dokukin).
